Hydrostatic Bearing Runner Damage at the Spain 64-m-Diameter Antenna

J. Chapman
DSN Quality Assurance Section

K. Bartos
DSIF Engineering Section

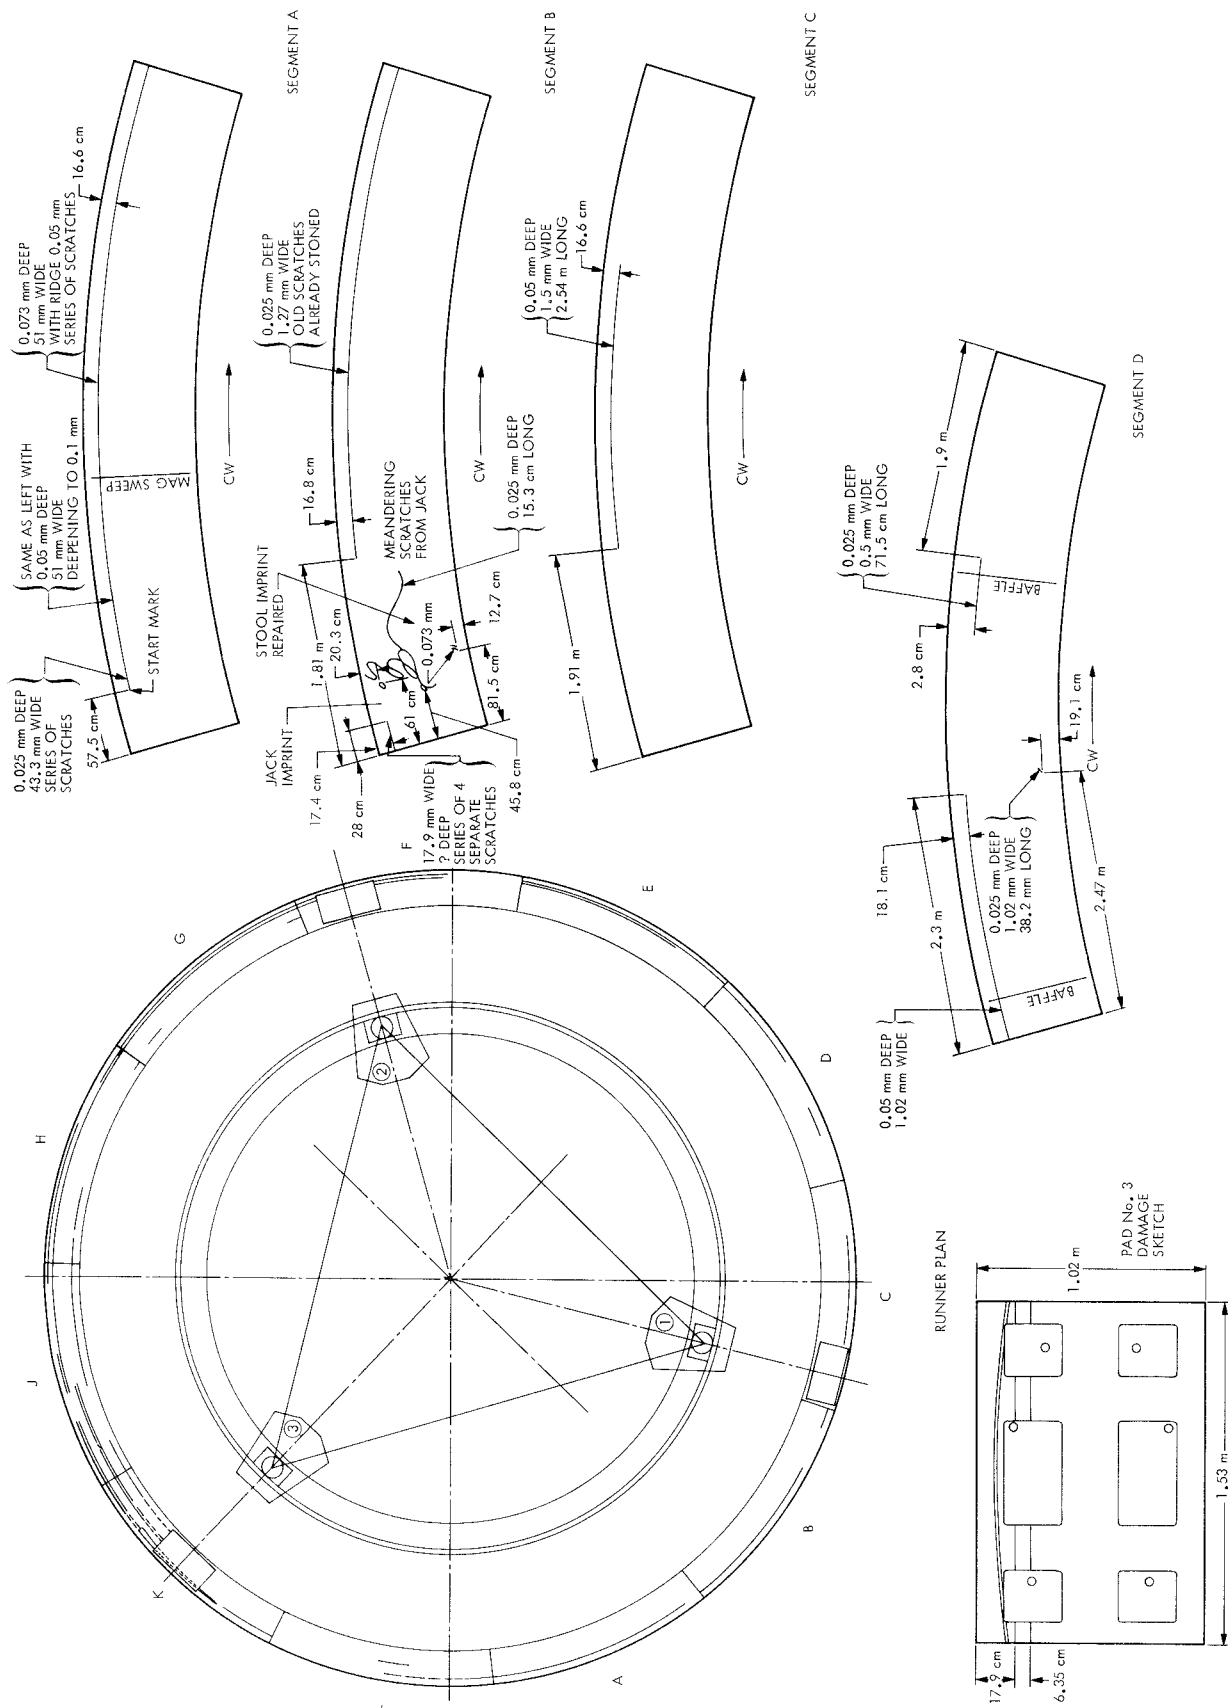
Fig. 1. Plan of Scratches

The 64-m-diameter antenna rotates in azimuth on a hydrostatic bearing that consists of a 7-in.-thick steel runner of eleven segments, segments A through L less I (Fig. 1), and three pads spaced 120° apart through which high pressure oil is pumped to support or "float" the 5.5-million-lb antenna. The plan view of Fig. 1 shows a typical relative orientation of the antenna base triangle, pads, and runner segments. On November 12, 1972, the rear pad grounded upon a foreign object resulting in damage to the runner and the rear pad.

Nearly the entire runner showed minor damage in the form of single and multiple scratches caused by a foreign object, presumably the same object that precipitated the grounding. The scratches varied in depth and width—a maximum depth of 0.1 mm and a maximum width of 1.5 mm. The scratches also showed characteristic upset material on either side of the scratch due to Poisson's ratio effect on the order of 0.05 mm above the runner surface. The radii of the scratches near the outside of the runner (Fig. 1) can be directly attributed to the foreign object being lodged under the outside corner film height sensor assemblies of the left front and rear pads and under the film height sensor assembly corresponding to the grounding on segment K while the antenna was being rotated. These three height sensor assemblies showed the same characteristic imprint pattern (Fig. 5). The multiplicity of the scratches implies that the object was either long or that the object was in the trough during several antenna rotations. Figure 6 shows the maps of the scratches on each individual runner segments.

The entire runner surface was hand stoned to remove all upset material along the sides of individual and multiple scratches.

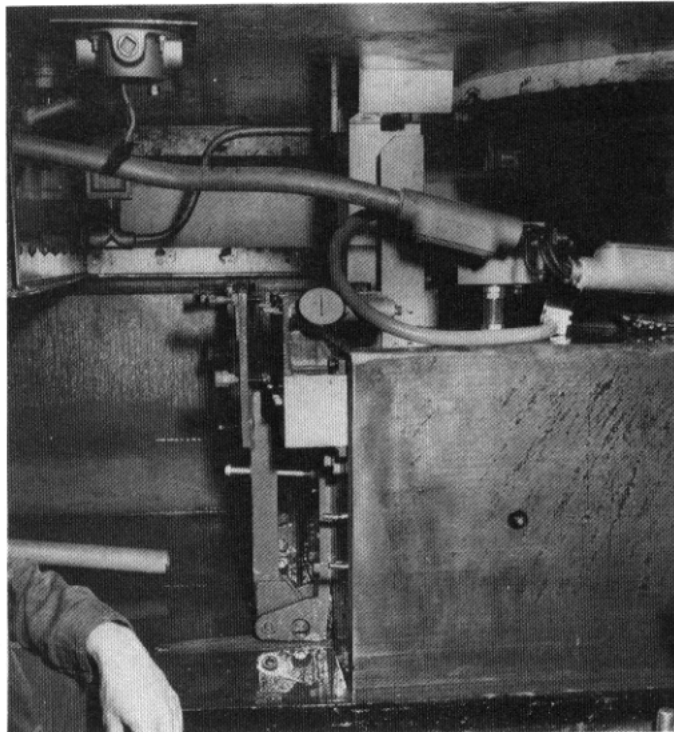
Fig. 2. Runner segment K

The major runner damage was confined to a 3-m length of runner segment K. As the antenna was being rotated

clockwise, a foreign object became caught between the runner and the film height sensor (skateboard). As the antenna motion continued, the foreign object gouged the runner that in turn precipitated pad damage as the pad moved over the damaged runner area. Damage to both the pad and runner continued until the friction force equaled the antenna rotating force. The damage consisted of a gouge varying from zero depth at the start point to approximately 1 cm deep near the end of the gouge.

The width varied from 1 cm to 5 cm. Figure 2 shows the maximum point of clockwise rotation, the damaged film height sensor, and the edge of the pad acting as a machine tool for cutting metal from the runner surface. (It is noted that the antenna was moved counterclockwise about 30 cm while trying to pinpoint the reason for non-motion immediately after the grounding occurred.)

The major damage of segment K was repaired by first removing all loose material. Dye penetrant was used to

assure that no cracks or laminar material remained prior to welding. The gouge was filled to above the level of the runner surface with E7018 weld material placed as stringer beads with spacing techniques used to prevent heat distortion of the runner. The temperature of the work area was maintained between 20 and 30°C. After welding the repair area was ground, filed, and hand stoned to remove excess weld material. The area was carefully measured to assure that the original runner flatness of 0.07 mm was obtained. In fact the flatness was better than 0.025 mm. Four isolated instances, three related to the foreign object, required welding repair and finishing as above.

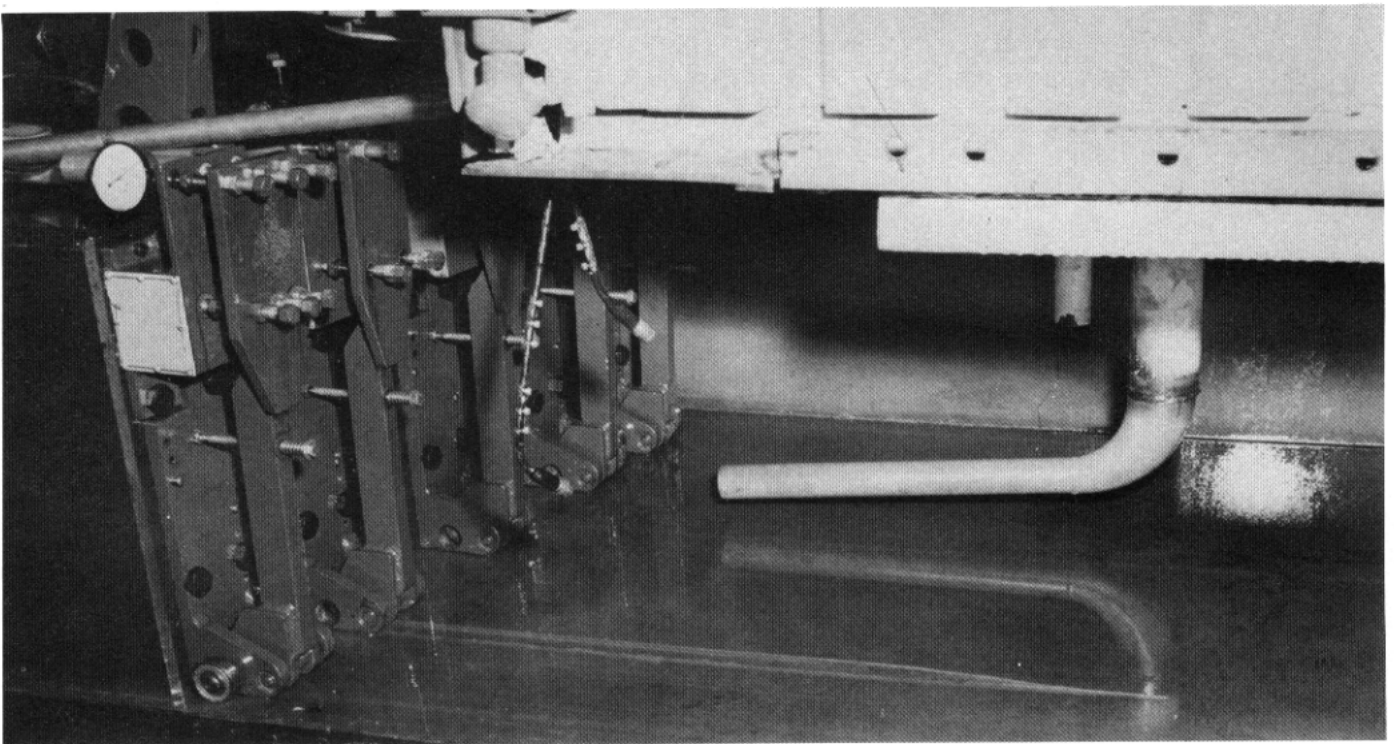
Fig. 3. Starting point of damage

Figure 3 shows the trailing edge of the pad, the starting point of the damage, and the typical film height sensors. Figures 4 and 5 show the characteristic print left by the foreign object on the runner at the starting point of damage and on the film height sensor.

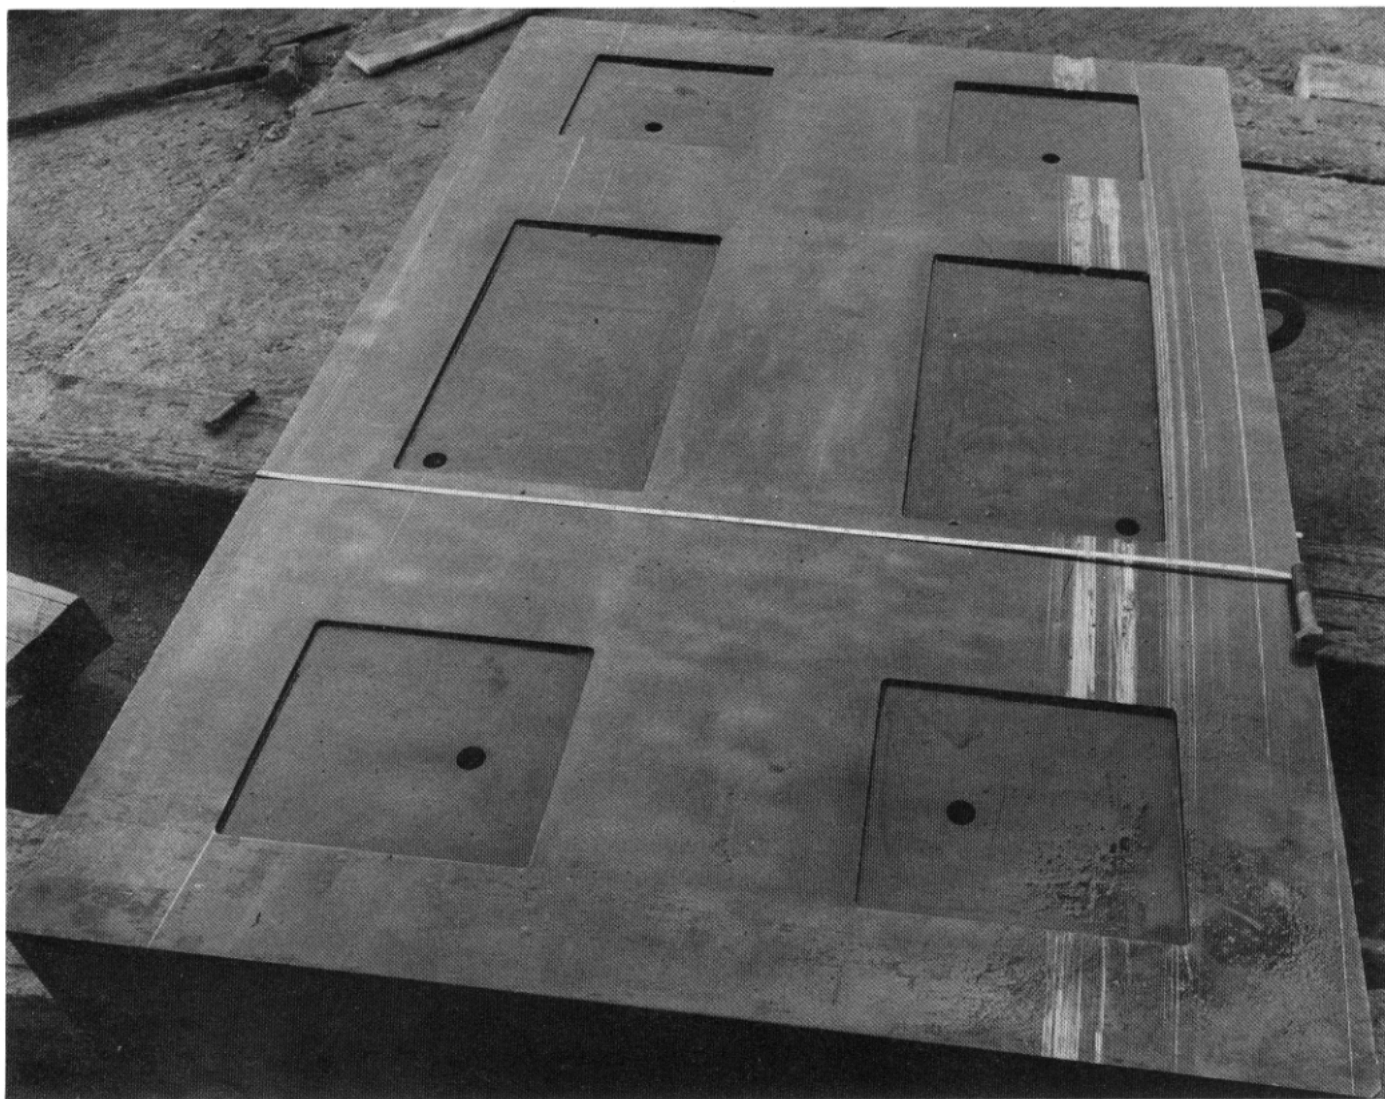
Fig. 7. Rear pad after removal

Rear pad damage was directly related and was a mirror image of the runner damage. Figure 7 shows the rear pad after removal. The other minor scratches are of the order of 0.07 mm in depth and correspond to the scratches that were made in the runner and then transferred to the pad, either by the upset material or small chips removed from the runner.

The damaged areas on the rear pad were ground out and inspected using dye penetrant to assure that no cracks or laminar material remained before welding. The pad was then shipped to Bilbao, Spain, to be placed in an oven for preheat prior to weld repair.

The fabrication shop and oven of Talleres San Miguel, a Collins Radio subcontractor, was used to preheat the pad. The pad was preheated for 6 h to 315°C and welding by a certified welder was started. After one hour the preheat decreased to 260°C the minimum set prior to starting repair. The pad was returned to the oven and heated again for 12 h at an oven temperature of 480°C. When the pad was removed, the temperature was 425 to 460°C, as checked with temperature sensitive crayons. The welding was done using an E 8018 welding rod placed as stringer passes. Each pass was cleaned with a wire brush and the weld checked using the magnetic particle method. As in the runner repair, sufficient weld material was placed to be sure that the repair areas were above the plane of the pad surface. After welding the pad was returned to the oven and heat treated to 650°C for 20 h.

After cooling the pad surface was measured and found slightly warped, a peak-to-peak measurement of 0.25 mm. The pad surface was ground in 0.02-mm increments until flat. After machining the pad surface was phosphate coated in accordance with MIL-P-16232 D, Type Z, Class 2.
